City of Bethel Yukon-Kuskokwim Fitness Center Leak Investigation and Mitigation Report

Date: 23 January 2020

Subject: Yukon Kuskokwim Fitness Center, Leak Investigation and Mitigation Report

Project Number: 12044.01

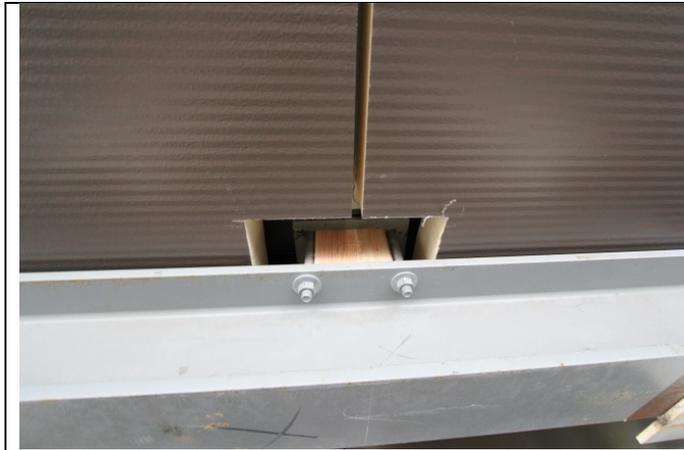
Reported Problem: No insulation is present between wood pile caps and insulated metal panels at several locations, resulting in significant cold air intrusion into the unheated concealed soffit.

Figure -1.1a. Gap at pile cap as seen during construction on April 3, 2014

Proposed Solution: Check all pile cap locations to verify which locations are missing insulation. When weather conditions allow, add foam-in-place insulation between pile caps and soffit panels as indicated in Detail C1/A5.01 of the construction drawings. Where the gap between pile caps and soffit panels exceeds 0'-1", provide prefinished metal flashing flush with the bottom (exterior) surface of the soffit panels, and fill gaps with foam-in-place insulation. See modified detail in Figure 1.1e.

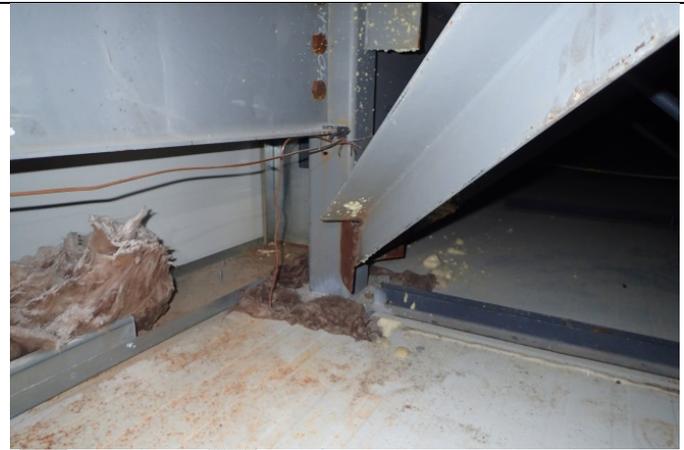
Emergency Repairs: At my suggestion on January 2nd, the City of Bethel Facilities and Property Crew stuffed all observed gaps in the thermal envelope with unfaced batt insulation as a measure to slow air intrusion.

Figure -1.1b. Batt insulation added to fill gaps at pile cap and soffit

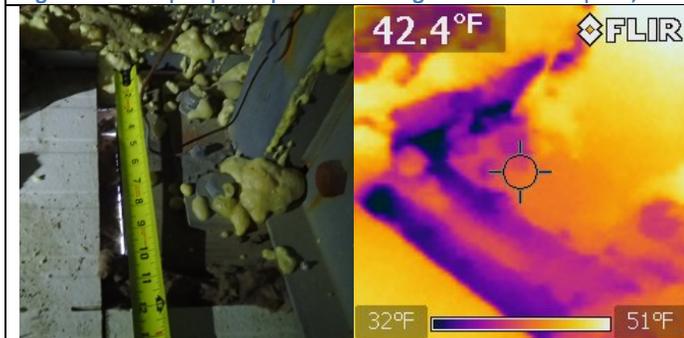
Observed conditions: During my site visit, I saw several such gaps between the insulated metal soffit panels and wood pile caps. These were filled with batt insulation as suggested. Mr. Ford removed some insulation in several locations, and daylight could be seen through large, previously unfilled gaps, demonstrating that it was a significant breach in the thermal envelope. Using a thermal camera, I was able to tell that the temporary batt insulation infill was performing nearly as well as the adjacent insulated metal panels. However, it should be pointed out that the soffit was being positively pressurized with Frost Fighter indirect fired heater. Without this pressurization, we anticipate that the lack of an air barrier would result in some cold air intrusion at these locations, although significantly less than without any insulation.

Figures -1.1c. and -1.1d. Pile cap at Grid H:10, with +/- 2" of missing insulation on two sides of pile cap, and daylight visible. (Note that spray foam was an attempt at emergency repair prior to filling gap with batt insulation.)

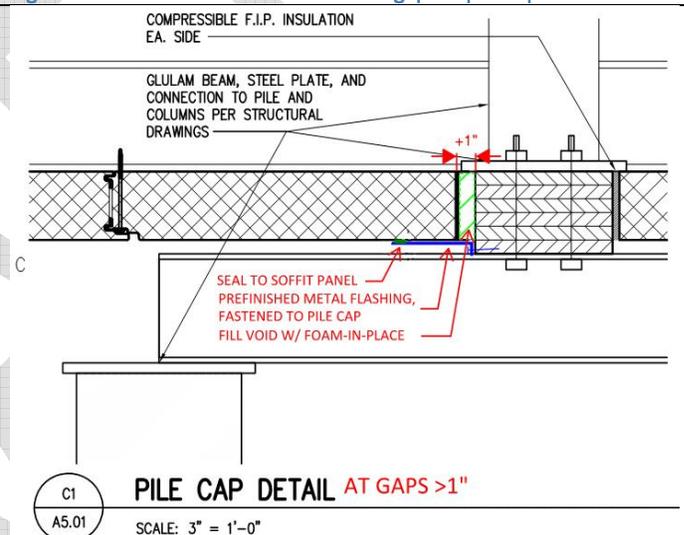
Fig 1.1e. Proposed gap insulation

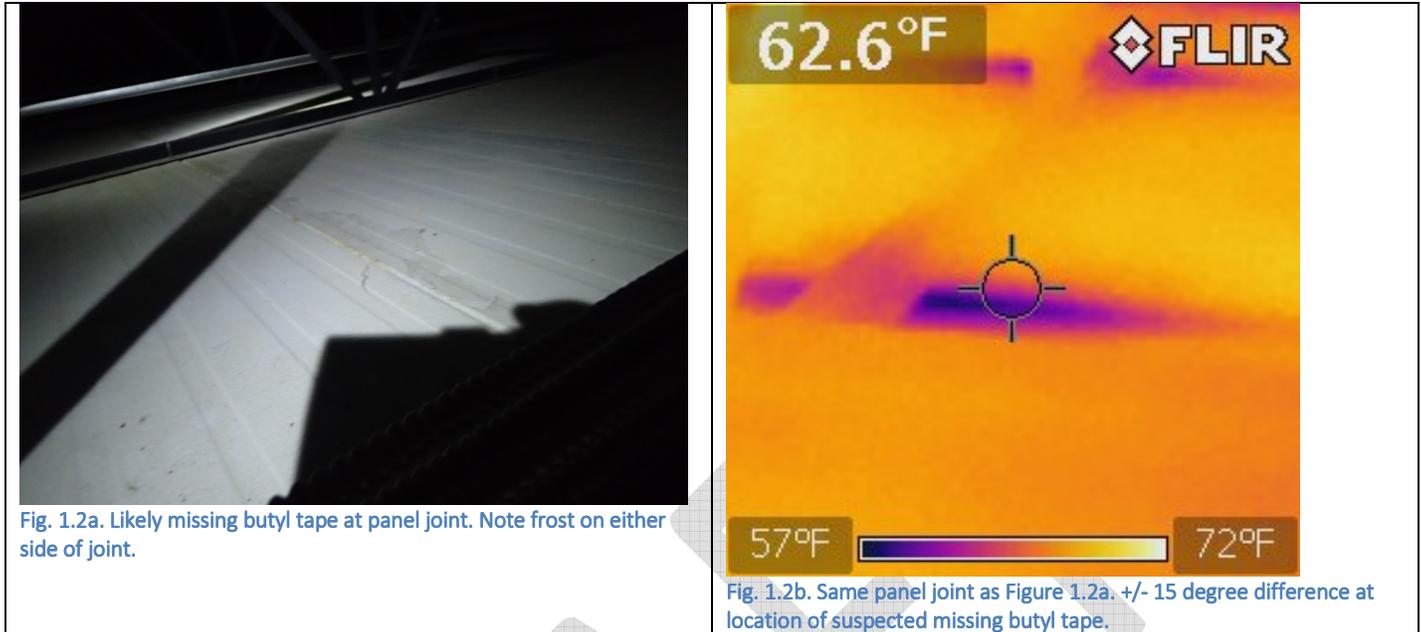
Reported Problem: Gaps in soffit panel joints permit cold air intrusion in several areas. This was reported both within the concealed and the accessible soffit spaces.

Observed Conditions: Cold air could be felt in the locations indicated by Mr. Ford. In addition, frost was visible on the interior surface of several panels where the surface temperature was lower than freezing point.

Proposed Solution: Mark all known locations of cold air intrusion. Apply sealant recommended by insulated metal panel manufacturer to seal gaps between panels.

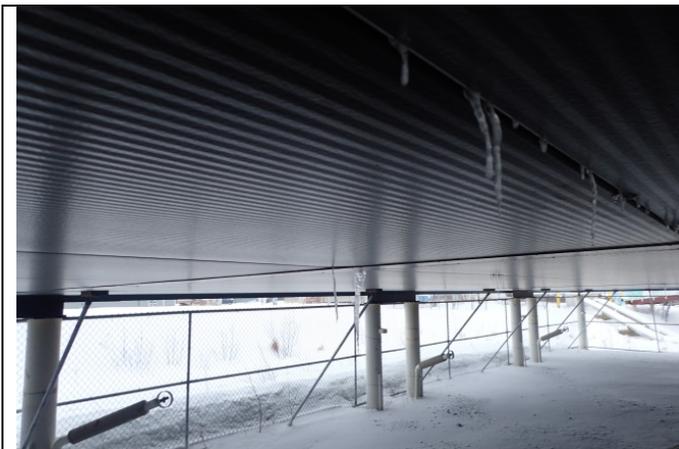
Observed Conditions: Ice was present in many (exterior) locations that had dripped from gaps in the soffit and wall framing of the concealed soffit space. The interior of the soffit north of Grid 9 did not have any water present at the time of my visit. I did not access the soffit between Grids 8 and 9 due to the presence of the Frost Fighter.

Fig. 1.4a. Significant amounts of ice at panel joints where water had leaked from burst piping.

Proposed Solution: Ensure that all moisture is removed from the soffit space. The Frost Fighter is likely dehumidifying the space while it is operating. However, crews should use a moisture meter to confirm that water has drained and evaporated to ensure that it does not create additional damage due to saturation, nor create an unhealthy environment due to mold.

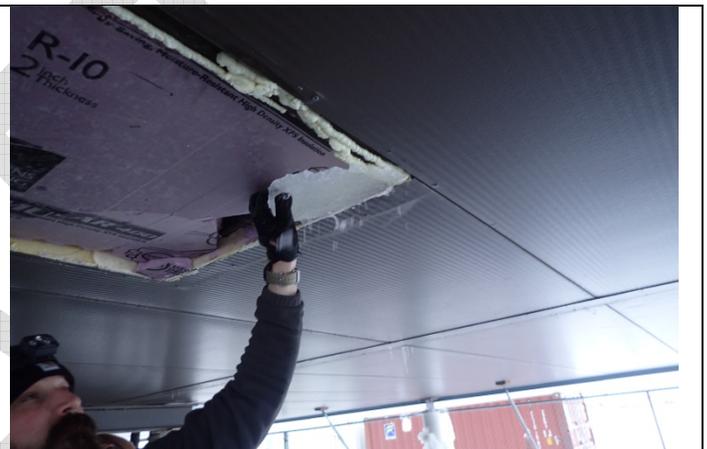
Fig. 1.4b. Ice present at access door cut into soffit panel.

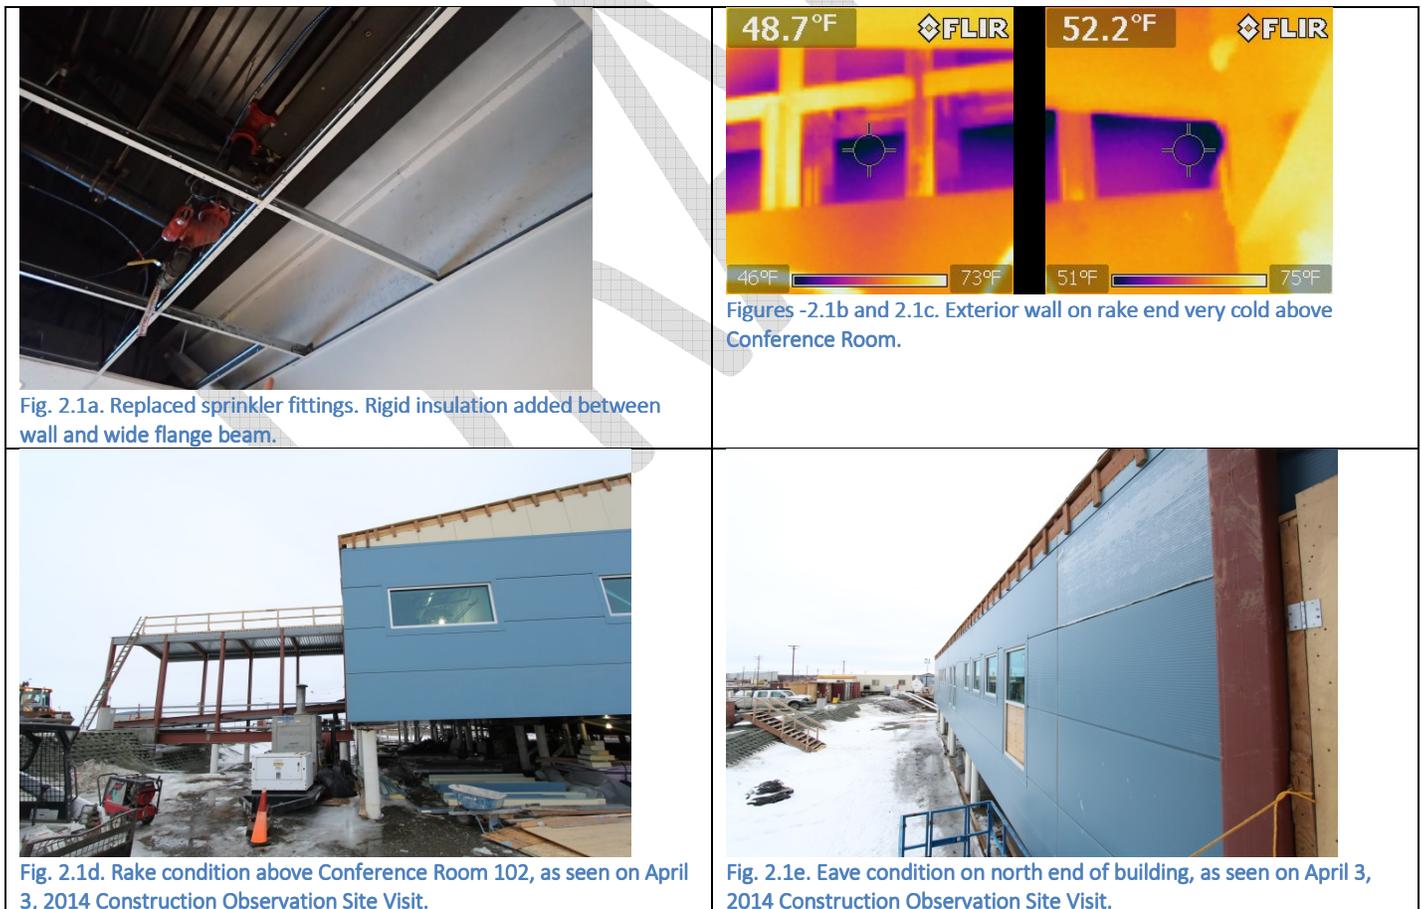
Reported Problem: frozen sprinkler piping was discovered above the ceilings of Conference Room 102 and Vestibule 100. Frozen pipes were reportedly discovered due to slow leaks into the rooms below; the system was drained before significant damage occurred. Significant cold air was felt in the area of the wide flange beam at the building eave.

Observed Conditions: Several ceiling tiles were removed in the Conference Room to allow for air circulation. Mr. Ford showed the cracked fittings that had been removed by Accel Fire. The thermal camera showed that the eave beam was warm; however, it was evident that the wide flange beam at the rake was extremely cold, likely due to missing insulation.

Proposed Solution: Check that insulation has been installed as indicated in the Construction Drawings. See details A1/A5.01 and B1/A5.01. Add insulation where missing. If insulation cannot be applied from exterior, an interior approach may be possible. However, care must be taken to ensure that structural steel does not become a cold bridge. See also memo from AMC Engineers regarding building controls.

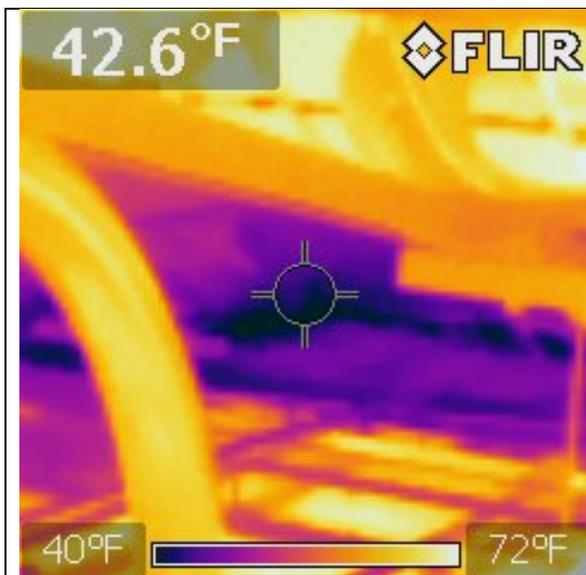
Observed Conditions: Same as Issue 2.1. In addition, it was noted that the wall separating Vestibule 100 from Corridor 101 was extended to the underside of the roof deck. This wall was shown in the construction drawings to terminate above the level of the ceiling, and then be open to other ceiling spaces above. (See Building Section A1/A3.01). The higher wall results in an enclosed space in which air cannot communicate to other ceiling spaces; this stagnant air puts wet piping further at risk of freezing because the arctic vestibule below and frequently open exterior doors results in a frequently cold room.

Fig. 2.2a. Eave condition above Vestibule 102. Note that it appears there is missing insulation at the transitions between soffit, wall, and roof.

Proposed Solution: Same as Issue 2.2. In addition, cut and remove GWB from 1'-0" above level of ceiling at north wall of Corridor 101 to the underside of the roof for the full width of the corridor, allowing air to communicate between ceiling spaces.

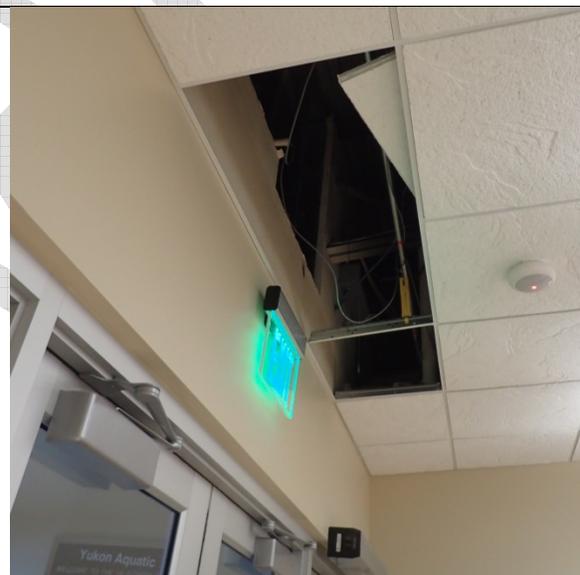
Fig. 2.2b. Wall framing and drywall continues vertically above vestibule doors..

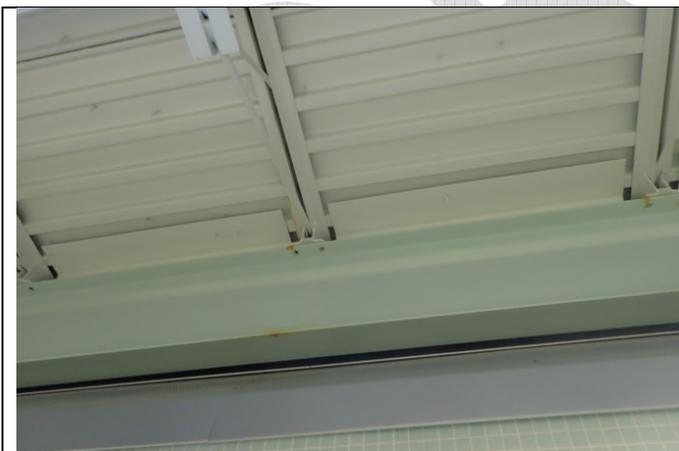
Reported Problem: Roof leaks reported between Grids 2 and 1, B and G during precipitation concurrent with South winds. Facility Manager Stacey Reardon reports that the length of the “mega truss” on Grid 2 between Grids B and G leaks into the pool, and that water drips down the length of the exposed roof joists to Grid 1. She also indicated that the windows on the south wall between grids B and D, and D and E leaked at the head condition during the same rain/wind events. Mr. Arnold indicates that south winds are predominant during the summer months, which corresponds to the times that Ms. Reardon indicates the leaks occur.

Observed Conditions: small areas of rust were apparent at the lowest point of open web joists in the area reported to leak. It appears evident that rain water penetrates along Grid 2, migrates down the structure, and follows the path of the bottom chords of trusses towards the south wall of the building. It is very likely that the windows do not leak, but instead, are subject to this same roof leak following the path of the joists, which then drips through the ventilated plenum assembly, and manifests itself at the head condition of the windows. I could not access the roof to see the condition of wall panels, roofing, or flashings.

Fig.3.1a. Small areas of rust on open web joists and wide flange, associated with leaking roof.

Proposed Solution: Inspect the roof and high wall assembly for obvious gaps in the transition between the high wall and the roof assembly. Specifically, check the condition and presence of flashing, self-adhered membrane, and foam closure as indicated in Detail D2/A5.01 of the Construction Drawings. If these items are present, it seems probable that wind-driven rain is being pushed through the foam closure and into the ventilated roof assembly below. If so, the flashing should be extended and an addition foam closure should be added. See revised detail D2/A5.01, shown in Figure 3.1f below. Clean areas of rust and apply touch-up paint to prevent further corrosion. Replace damaged GWB near Grid G:2.

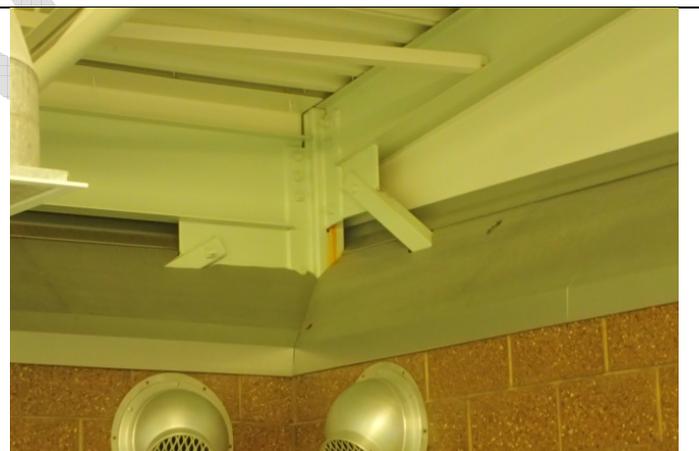
Note: rust was also noted on Column A:1. The source of this is unknown.

Figures -3.1b Rust noted on Column A:1.

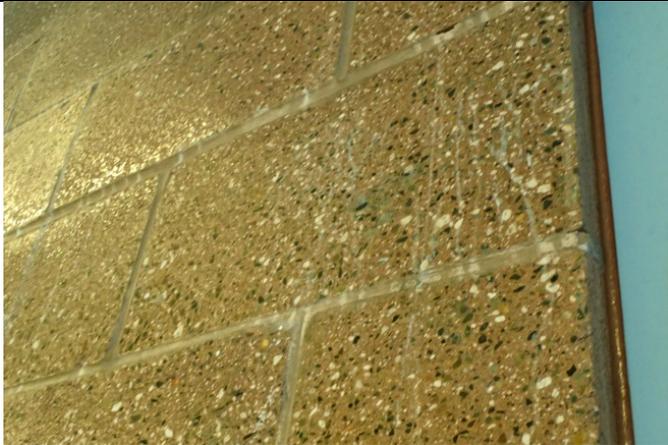
Fig. 3.1c. Efflorescence on CMU and Grout near Pool Equipment Storage

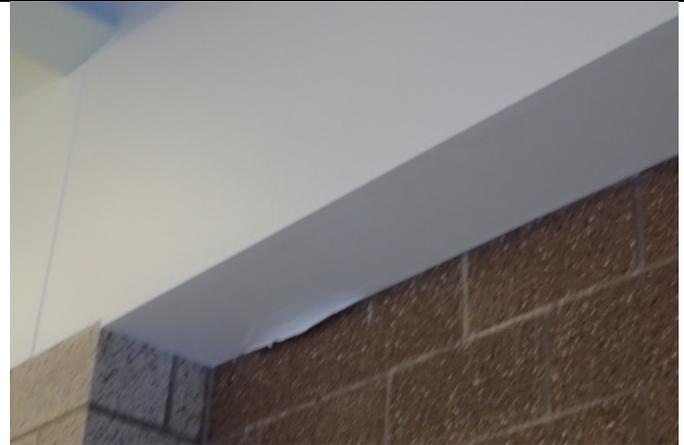
Fig. 3.1d. Damaged GWB at bulkhead near Grid G:2.

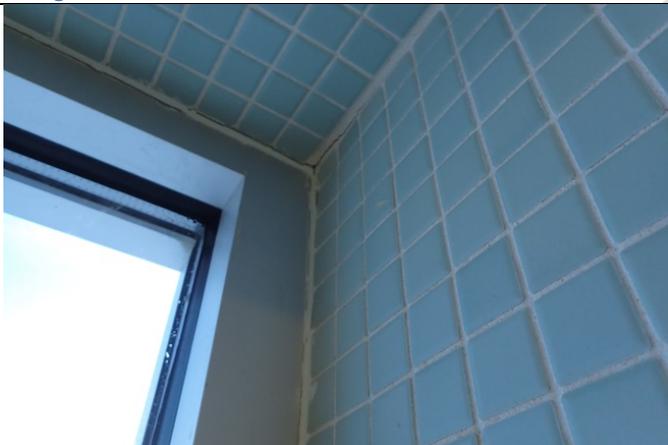
Fig. 3.1e. Cracked tile in soffit of window well. Cracks may be associated with water damage, but may also be associated with building movement. Monitor for further movement.

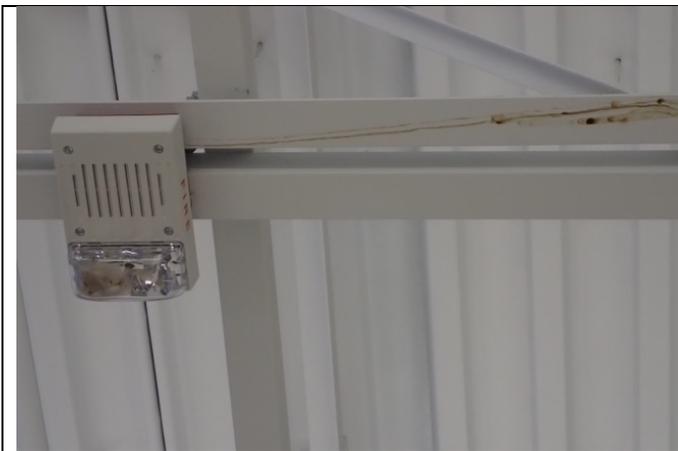
Observed Conditions: Same as Issue 3.1. Windows in these rooms have not been reported to leak. Note that one fire alarm device in Exercise Room 107 shows signs of water intrusion in the strobe.

Fig. 3.2a. Damaged strobe/annunciator. Inspect to ensure it is still operational and replace if not. Install metal flashing to divert leaking from causing further damage.

Proposed Solution: Same as Issue 3.1. Also, check the affected fire alarm device and replace if inoperable. We also suggest adding a temporary piece of flashing “uphill” from the fire alarm to divert drip water away from fire alarm until the roof leaks can be fixed.

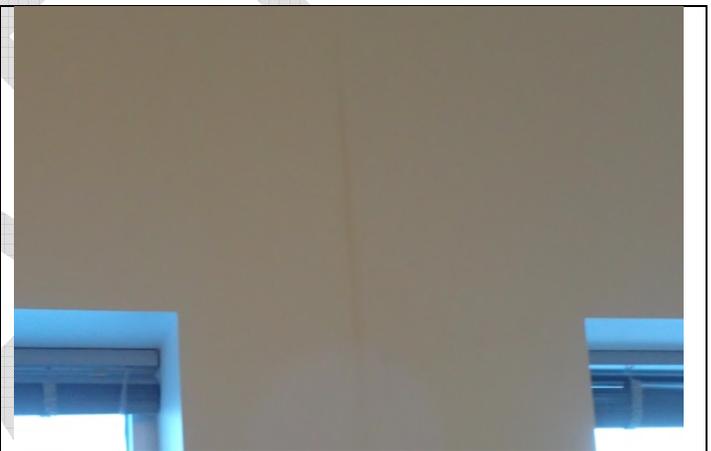
Fig. 3.2b. Minor water damage noted between windows in Exercise Room.

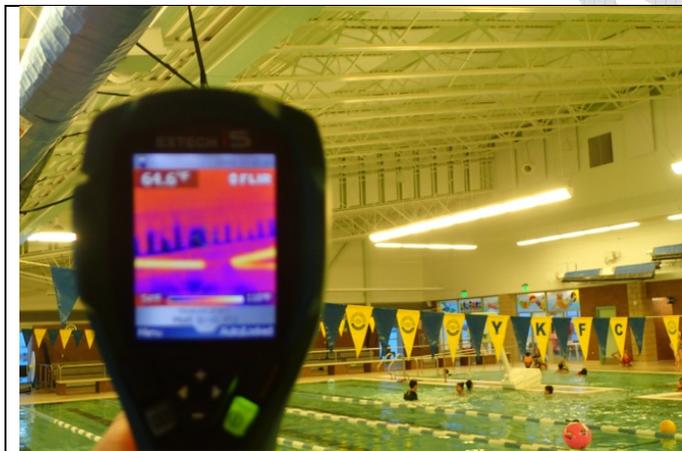
- East Side: the added insulation could be seen between wall framing. At Grid G:2, water damage was evident in the form of bubbling paint and efflorescence in the CMU.
- West Side: although no problems have been reported, it was evident with the thermal camera that the transition between the low roof and the high wall was significantly colder than the surrounding roof and wall construction.

Fig. 4a. Very cold roof:high wall transition

Proposed solution: (Applies to both west and east high walls). Inspect roof flashings and membranes for weather-tight and air-tight construction, and repair any damage found. Supplemental insulation may be needed: install closed-cell foam insulation on the interior side of the low roof to high wall transition for full length of high walls. Check for similar conditions on the north side of the building. See proposed detail in Figure 4c.

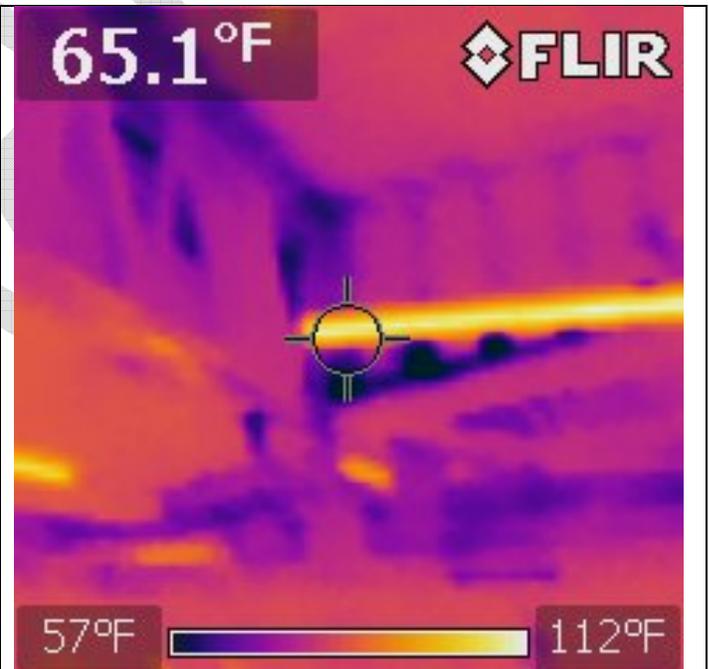
Fig. 4b. Roof to High wall transition at Grid B:2

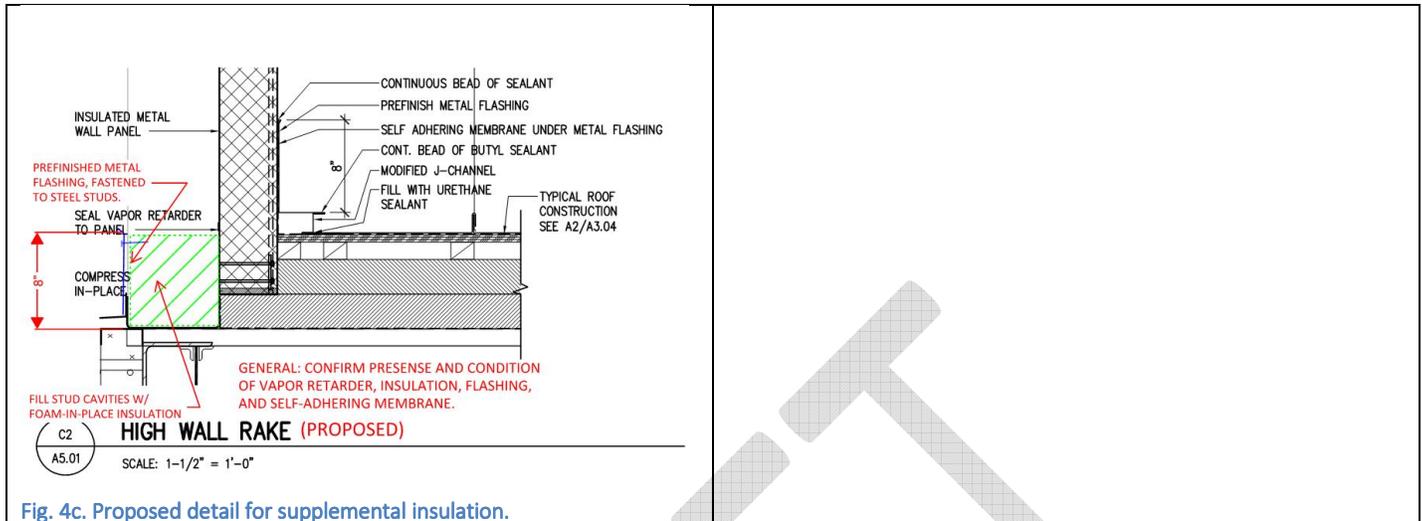
Fig. 4c. Proposed detail for supplemental insulation.

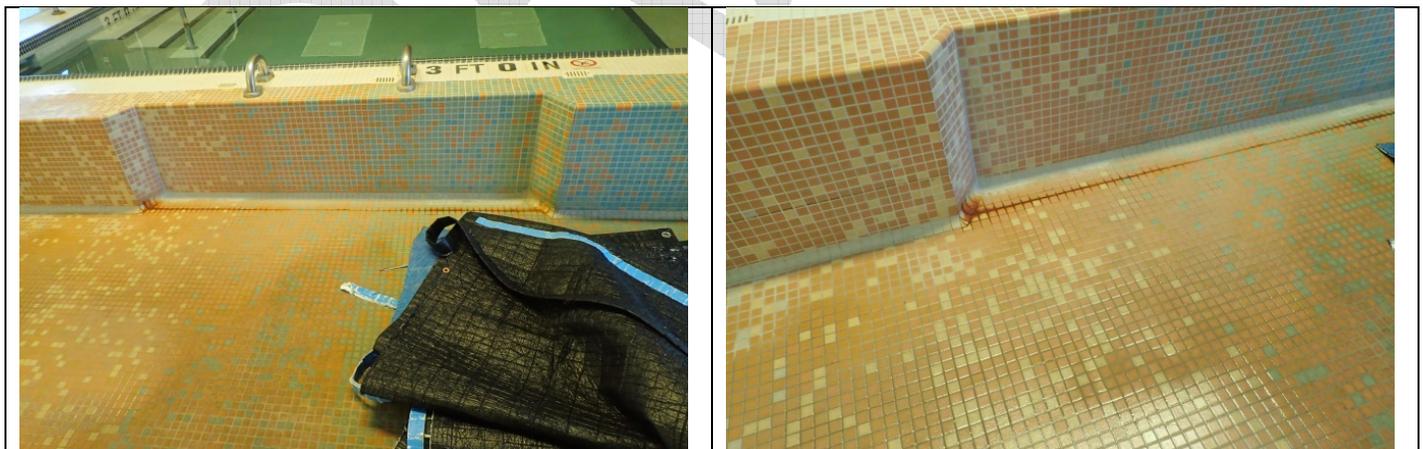
Observed Conditions: Standing water on the deck of the Viewing Area from the Spa pool covers has resulted in stained tile and grout on the viewing area deck. Mildew was seen on the floor tile indicating that standing water in this location is common. Rust staining was seen in the inset area of tile on the spa wall, and staining continued up the surface of the wall.

Fig. 5a. Pool cover results in standing water, staining of tile and grout, and saturation of concrete deck to rebar below.

Figures -5b: detail of staining.

Proposed Solution: Clean mildew from tile and grout. Monitor rust staining for advancement. Develop operational protocols to a) place wet pool covers on an area of the deck with positive drainage, and b) use a squeegee to remove standing water from the Viewing Area deck.
