City of Bethel
Public Works Committee
Regular Meeting - Wednesday, February 19, 2020 5:30 pm
City Hall Council Chambers, Bethel, AK

City of Bethel Yukon-Kuskokwim Fitness Center Leak Investigation and Mitigation Report

Subject: Yukon Kuskokwim Fitness Center, Leak Investigation and Mitigation Report

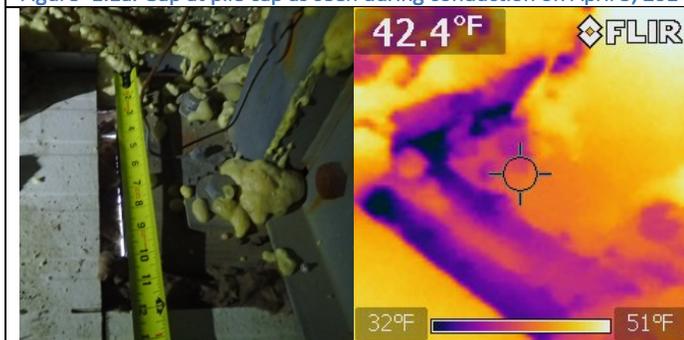
Observed conditions: During my site visit, I saw several such gaps between the insulated metal soffit panels and wood pile caps. These were filled with batt insulation as suggested. Mr. Ford removed some insulation in several locations, and daylight could be seen through large, previously unfilled gaps, demonstrating that it was a significant breach in the thermal envelope. Using a thermal camera, I was able to tell that the temporary batt insulation infill was performing nearly as well as the adjacent insulated metal panels. However, it should be pointed out that the soffit was being positively pressurized with Frost Fighter indirect fired heater. Without this pressurization, we anticipate that the lack of an air barrier would result in some cold air intrusion at these locations, although significantly less than without any insulation.

Figures -1.1c. and -1.1d. Pile cap at Grid H:10, with +/- 2" of missing insulation on two sides of pile cap, and daylight visible. (Note that spray foam was an attempt at emergency repair prior to filling gap with batt insulation.)

Proposed Solution: Check all pile cap locations to verify which locations are missing insulation. When weather conditions allow, add foam-in-place insulation between pile caps and soffit panels as indicated in Detail C1/A5.01 of the construction drawings. Where the gap between pile caps and soffit panels exceeds 0'-1", provide prefinished metal flashing flush with the bottom (exterior) surface of the soffit panels, and fill gaps with foam-in-place insulation. See modified detail in Figure 1.1e.

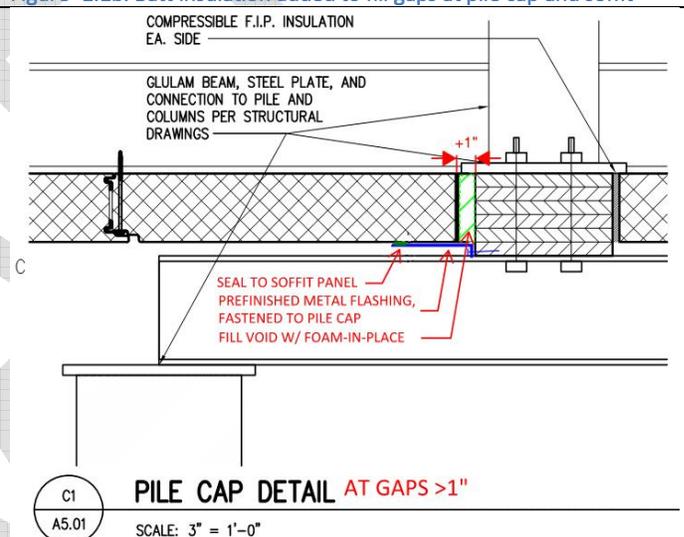
Fig 1.1e. Proposed gap insulation

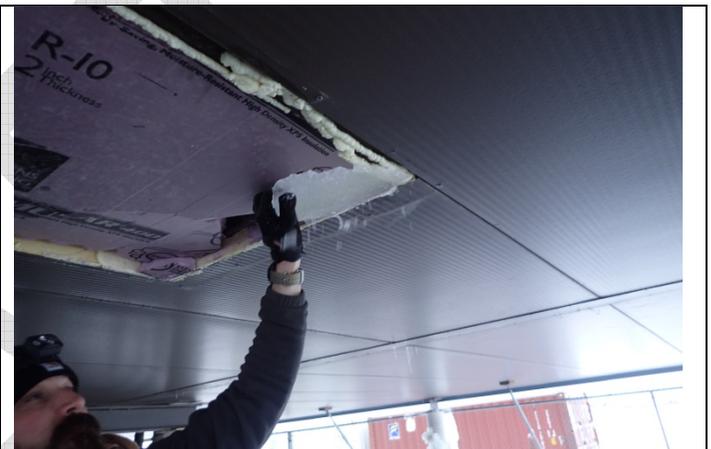
Observed Conditions: Ice was present in many (exterior) locations that had dripped from gaps in the soffit and wall framing of the concealed soffit space. The interior of the soffit north of Grid 9 did not have any water present at the time of my visit. I did not access the soffit between Grids 8 and 9 due to the presence of the Frost Fighter.

Fig. 1.4b. Ice present at access door cut into soffit panel.

Proposed Solution: Ensure that all moisture is removed from the soffit space. The Frost Fighter is likely dehumidifying the space while it is operating. However, crews should use a moisture meter to confirm that water has drained and evaporated to ensure that it does not create additional damage due to saturation, nor create an unhealthy environment due to mold.

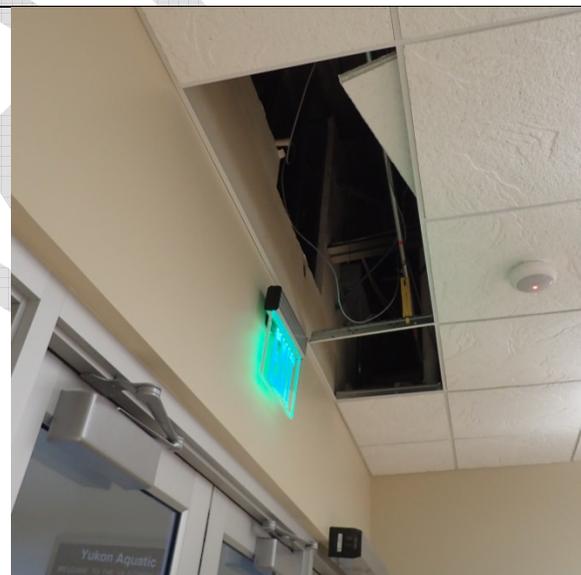
Observed Conditions: Same as Issue 2.1. In addition, it was noted that the wall separating Vestibule 100 from Corridor 101 was extended to the underside of the roof deck. This wall was shown in the construction drawings to terminate above the level of the ceiling, and then be open to other ceiling spaces above. (See Building Section A1/A3.01). The higher wall results in an enclosed space in which air cannot communicate to other ceiling spaces; this stagnant air puts wet piping further at risk of freezing because the arctic vestibule below and frequently open exterior doors results in a frequently cold room.

Fig. 2.2b. Wall framing and drywall continues vertically above vestibule doors..

Proposed Solution: Same as Issue 2.2. In addition, cut and remove GWB from 1'-0" above level of ceiling at north wall of Corridor 101 to the underside of the roof for the full width of the corridor, allowing air to communicate between ceiling spaces.

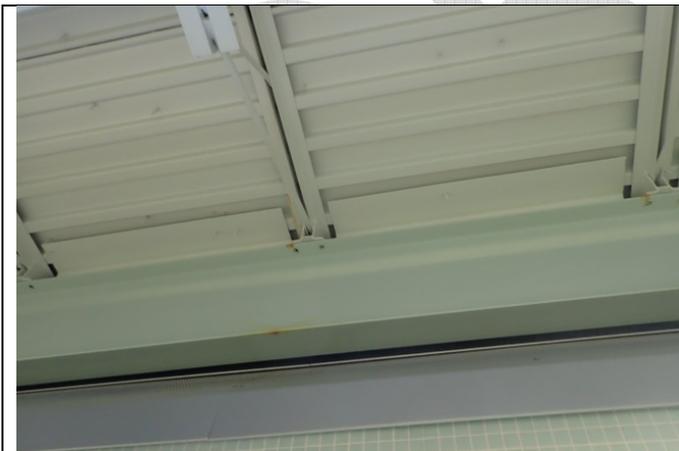
Observed Conditions: small areas of rust were apparent at the lowest point of open web joists in the area reported to leak. It appears evident that rain water penetrates along Grid 2, migrates down the structure, and follows the path of the bottom chords of trusses towards the south wall of the building. It is very likely that the windows do not leak, but instead, are subject to this same roof leak following the path of the joists, which then drips through the ventilated plenum assembly, and manifests itself at the head condition of the windows. I could not access the roof to see the condition of wall panels, roofing, or flashings.

Fig.3.1a. Small areas of rust on open web joists and wide flange, associated with leaking roof.

Proposed Solution: Inspect the roof and high wall assembly for obvious gaps in the transition between the high wall and the roof assembly. Specifically, check the condition and presence of flashing, self-adhered membrane, and foam closure as indicated in Detail D2/A5.01 of the Construction Drawings. If these items are present, it seems probable that wind-driven rain is being pushed through the foam closure and into the ventilated roof assembly below. If so, the flashing should be extended and an addition foam closure should be added. See revised detail D2/A5.01, shown in Figure 3.1f below. Clean areas of rust and apply touch-up paint to prevent further corrosion. Replace damaged GWB near Grid G:2.

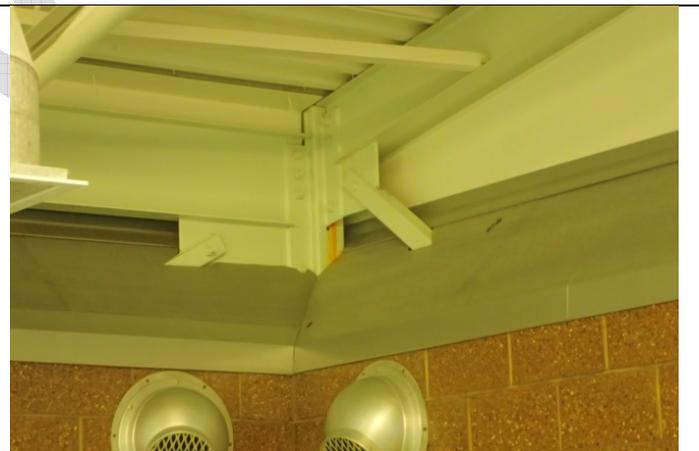
Note: rust was also noted on Column A:1. The source of this is unknown.

Figures -3.1b Rust noted on Column A:1.

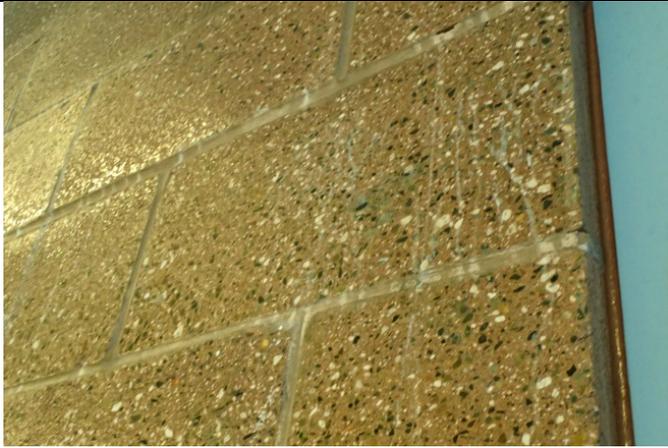
Fig. 3.1c. Efflorescence on CMU and Grout near Pool Equipment Storage

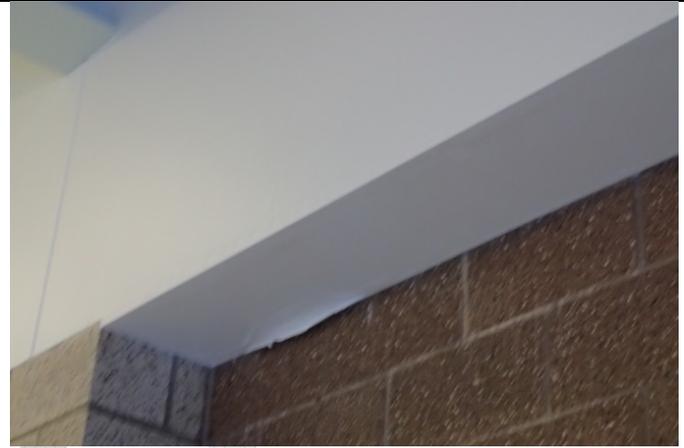
Fig. 3.1d. Damaged GWB at bulkhead near Grid G:2.

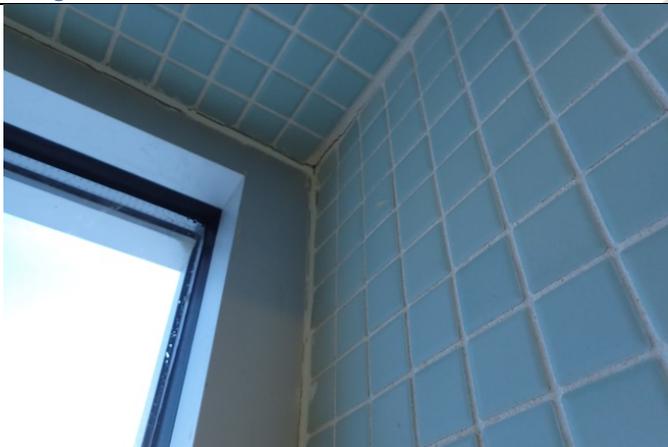
Fig. 3.1e. Cracked tile in soffit of window well. Cracks may be associated with water damage, but may also be associated with building movement. Monitor for further movement.

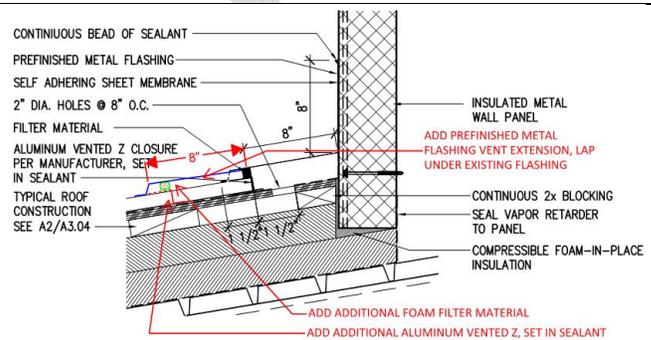
D2 HIGH WALL EAVE EXTENSION
 A5.01 SCALE: 1 1/2" = 1'-0"

Fig. 3.1f. Extend highwall eave flashing. Add additional vented z closure and additional foam closure.

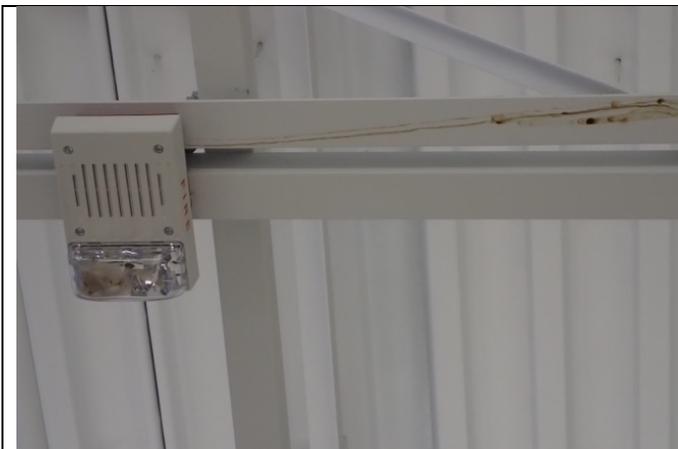
Observed Conditions: Same as Issue 3.1. Windows in these rooms have not been reported to leak. Note that one fire alarm device in Exercise Room 107 shows signs of water intrusion in the strobe.

Fig. 3.2a. Damaged strobe/annunciator. Inspect to ensure it is still operational and replace if not. Install metal flashing to divert leaking from causing further damage.

Proposed Solution: Same as Issue 3.1. Also, check the affected fire alarm device and replace if inoperable. We also suggest adding a temporary piece of flashing “uphill” from the fire alarm to divert drip water away from fire alarm until the roof leaks can be fixed.

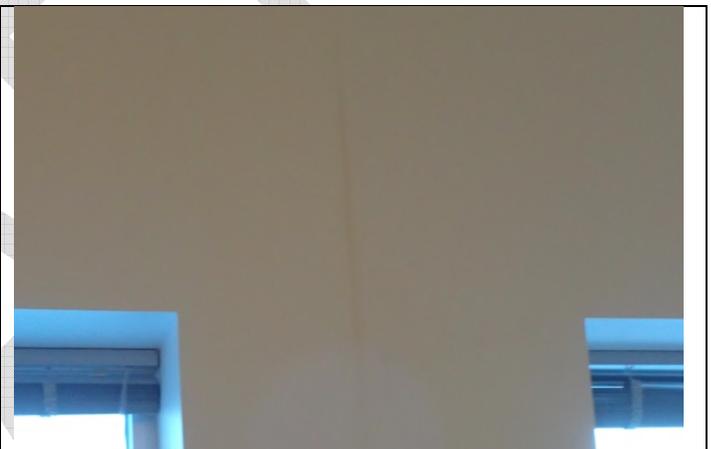
Fig. 3.2b. Minor water damage noted between windows in Exercise Room.
